**CULTURAL LANDSCAPE REPORT  
NORTH BRIDGE UNIT  
MINUTE MAN NATIONAL HISTORICAL PARK**

**SITE HISTORY, EXISTING CONDITIONS,  
ANALYSIS & EVALUATION, TREATMENT RECOMMENDATIONS**

**CONCORD  
MASSACHUSETTS**

January 2004

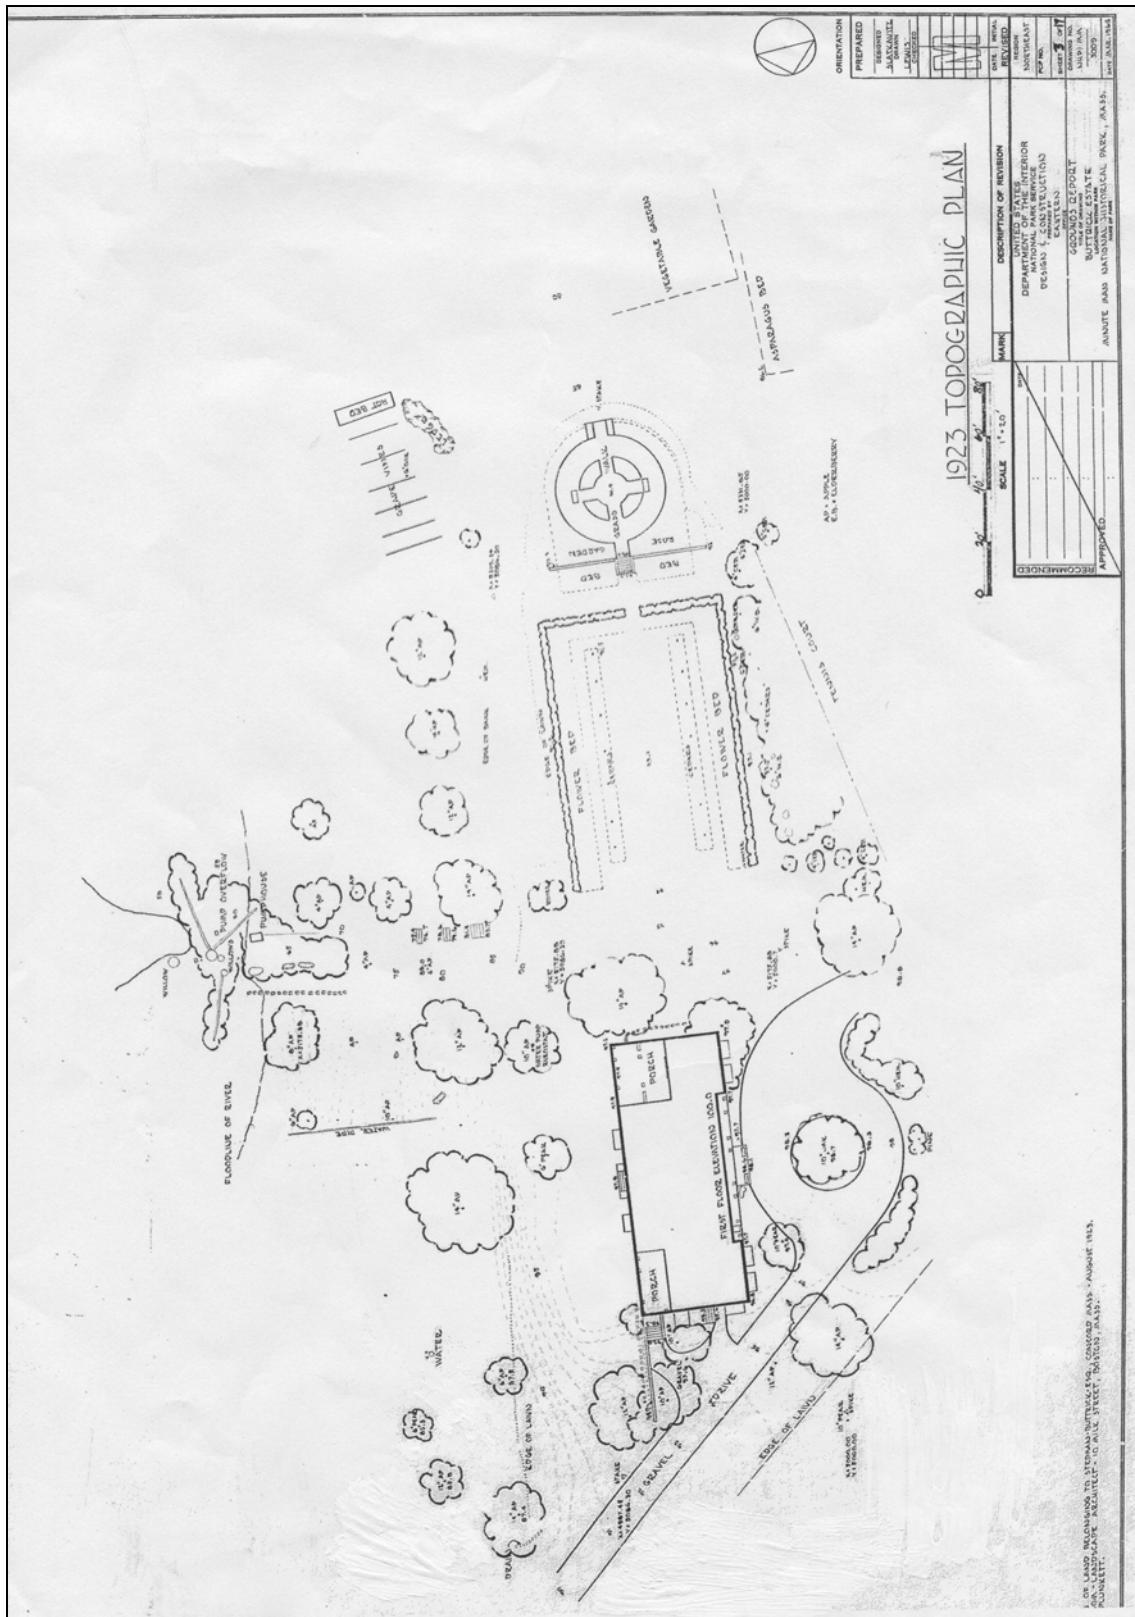
Figure 57. NPS tracing of "Topographical Plan of Land Belonging to Stedman Buttrick, Esq., Concord, Mass.," 1923, tracing 1964 (Original located in MIMA Archives, MIMA 24474)

A topographical plan prepared by Blossom in 1923 reveals existing landscape features not included on Charles H. Wheeler’s 1911 planting plan, including a circular garden (lower garden) south of Wheeler’s rectangular garden, and a series of steps leading down the east slope of Buttrick Hill towards the river (Figure 57).<sup>149</sup> The same year, Blossom prepared a preliminary garden plan that included a flagstone path connecting the two gardens and stairs leading to the river. He also redesigned the configuration of flower beds in the circular garden (lower garden) (Figure 58). Many or all of his proposed changes appear to have been implemented. In 1925, the same year Stedman Buttrick II died, Blossom prepared an extensive perennial planting plan for the circular garden.<sup>150</sup> It is not known if Blossom’s perennial planting plan was ever implemented.

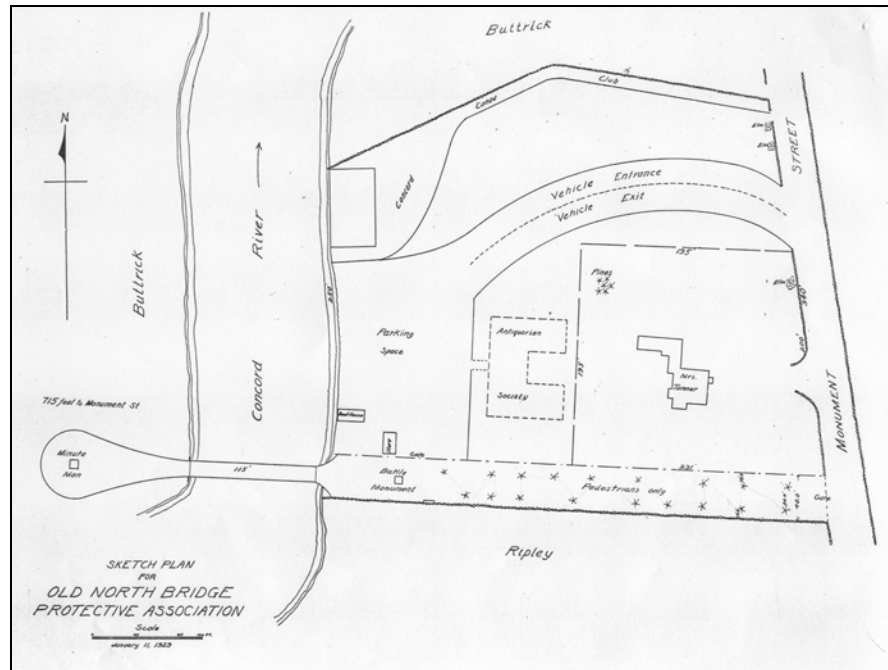
Figure 63. "Sketch Plan for Old North Bridge Protective Association," January 11, 1929. In addition to the proposed features (parking lot, vehicular drive, and Antiquarian Society building), the plan also depicts several existing features. Commemorative features represented on the map include the avenue to the bridge and a gated entrance, the allée, the bridge and the monuments. Non-commemorative landscape features include the Tanner (Simmons) house, the Concord Canoe Club, a small unnamed boathouse (Simmons Boathouse), and a tourist stand. (Special Collections, C. Pam. 72, Item 7, Concord Free Public Library)

The town hoped to acquire the parcel owned by Mrs. James D. Tanner to construct a new building to house the Antiquarian Society and a large parking lot to provide automobile parking for visitors to the Antiquarian Society and to the North Bridge. A proposed access road would provide access to both the parking lot and the Antiquarian Society building from Monument Street (Figure 63). Soon after completion of the plan, the Antiquarian Society chose another building site and the town abandoned the project.

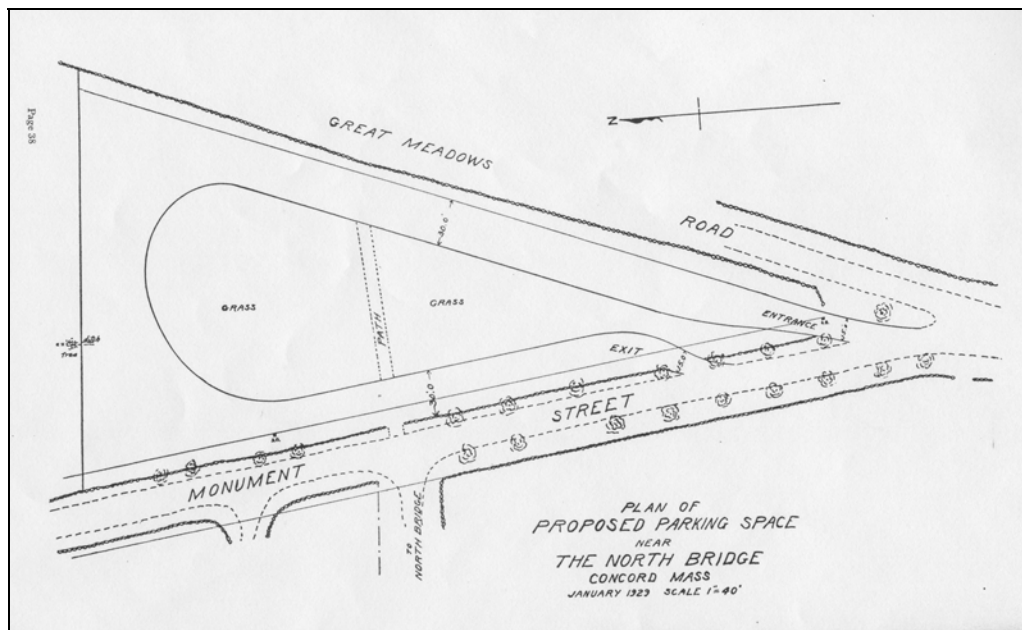
Figure 64. "Plan of Proposed Parking Space near the North Bridge, Concord Mass.," January 1929. (1928 Concord Annual Report, Concord Free Public Library)

In 1929, the town constructed a parking lot on the eastern side of Monument Street, across from the entrance to the battleground, in the triangular parcel identified in House Bill 930. The previous year automobiles had been restricted from entering the avenue leading to the North Bridge because they “caused confusion and because much paper and other refuse was strewn about the grounds by motorists holding picnics under the trees.”<sup>160</sup> The parking lot accommodated both automobiles and tour buses (Figure 64).<sup>161</sup> In 1930, the town constructed an additional entrance to the parking lot (north entrance), erected granite posts at all three entrances/exits, planted trees and shrubs along the north and south sides of the parking lot, and installed a drinking fountain. In 1954, the town built a public toilet facility adjoining northern boundary of the lot.<sup>162</sup>

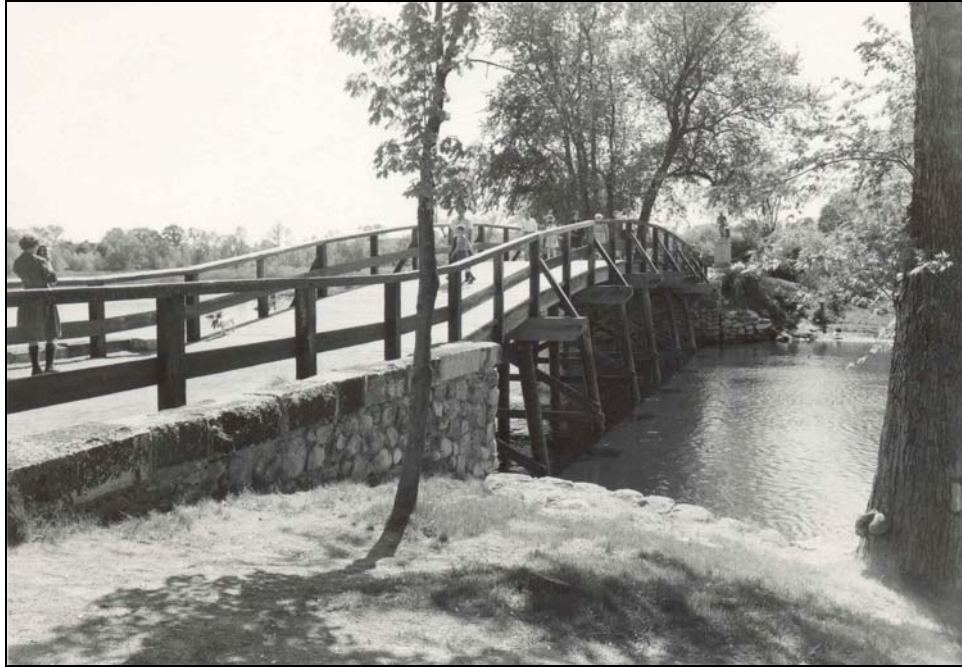
**Figure 66. View southwest of the 1956 commemorative North Bridge, 1962. Also visible in the background is The Minute Man statue. (Photograph by Jack Boucher, 1962, HABS/HAER, #62-107, MIMA Library)**

The same year, record floodwaters damaged the 1909 commemorative North Bridge beyond repair. In 1956, the Commonwealth of Massachusetts constructed the fourth commemorative North Bridge (extant), with funds allocated by the federal government for New England disaster relief. Responding to local protests against replicating the bridge in concrete as the 1909 bridge had been constructed; the state constructed the 1956 commemorative North Bridge with pressure treated timbers (Figure 66).<sup>179</sup>

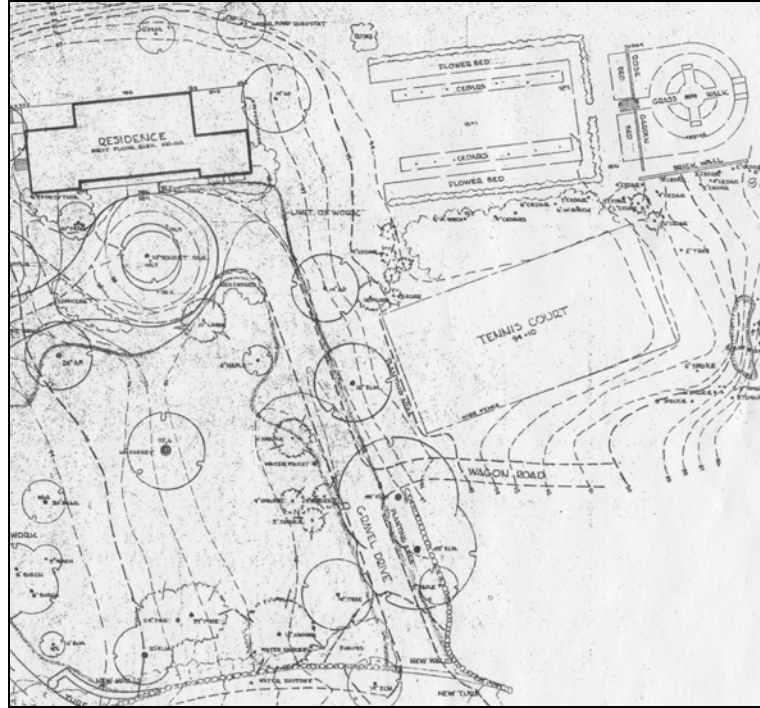
**Figure 70.** Section of a NPS tracing of “Stedman Buttrick, Esq. Topographical Plan of Land,” 1928, tracing 1964. A section of Groton Road is depicted on the map, labeled ‘wagon road’ in the lower left. See Appendix B for the complete plan. (Original located in MIMA Archives, MIMA 24466)

The linear garden leading the Battle Lawn/Overlea mansion cut across the site of the original tennis courts and passed over the Groton Road site. It is not known if any sections of the Groton Road were exposed by the 1940s and 1950s; however, at least the section lying under the garden is known to have existed as late as 1928. This portion of the road is depicted on the “Stedman Buttrick, Esq. Topographical Plan of Land” as a wagon road (Figure 70).

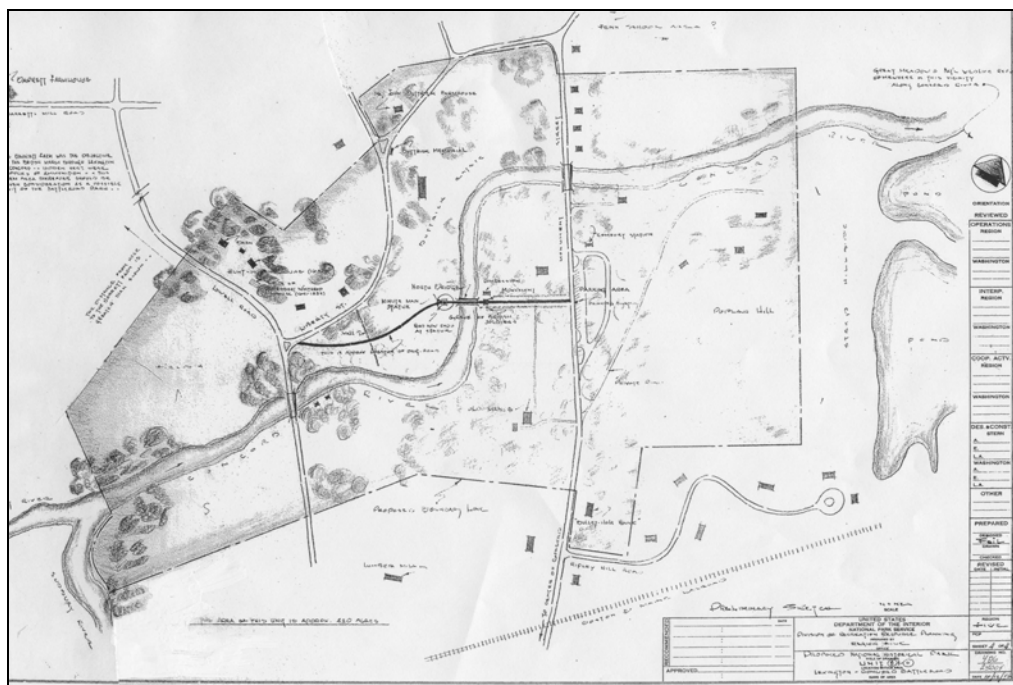
Figure 71. NPS Preliminary Sketch, "Proposed National Historical Park," 10/12/56

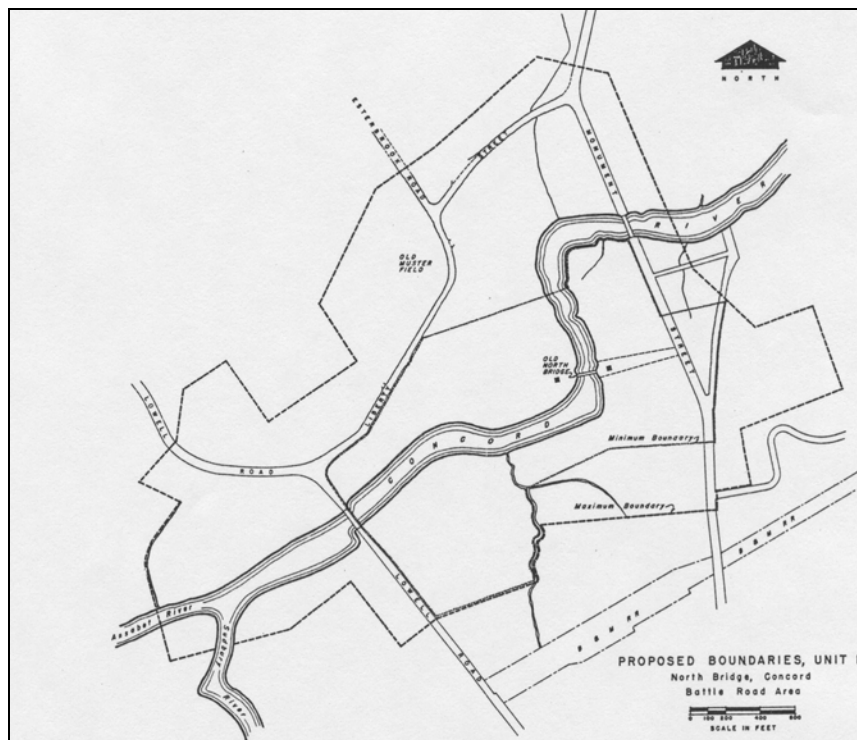
**Figure 73. “Proposed Boundaries, Unit B,” North Bridge, Concord. (Boston National Historic Sites Commission, Interim Report, 1958)**

Commenting on the size of the existing commemorative landscape within proposed Unit B (present-day North Bridge Unit), the commission stated “the historic site barely covers the immediate battleground at the bridge and is even smaller than its parking area.”<sup>196</sup> It also noted that the configuration and size of the public landscape did not provide an accurate depiction of the Concord battleground. A heavy screen of shrubbery behind The Minute Man statue blocked views of the colonial avenue of approach and gave visitors a false impression that The Minute Man statue marked the terminal point of the British advance. The shrubs also prevented views of landscape features that played significant roles during the battle. These features included the Muster Field, where the colonial forces assembled before descending down to the bridge, and the low-lying riverside meadow, where the old road passed over a causeway as it approached the bridge. The commission recommended expanding the extant commemorative landscape to include the properties mentioned above. It also recommended the purchase or protection of additional lands as buffers, to forestall residential or other undesirable development adjacent to the proposed park that would detract from the historical scene (Figure 73).<sup>197</sup>

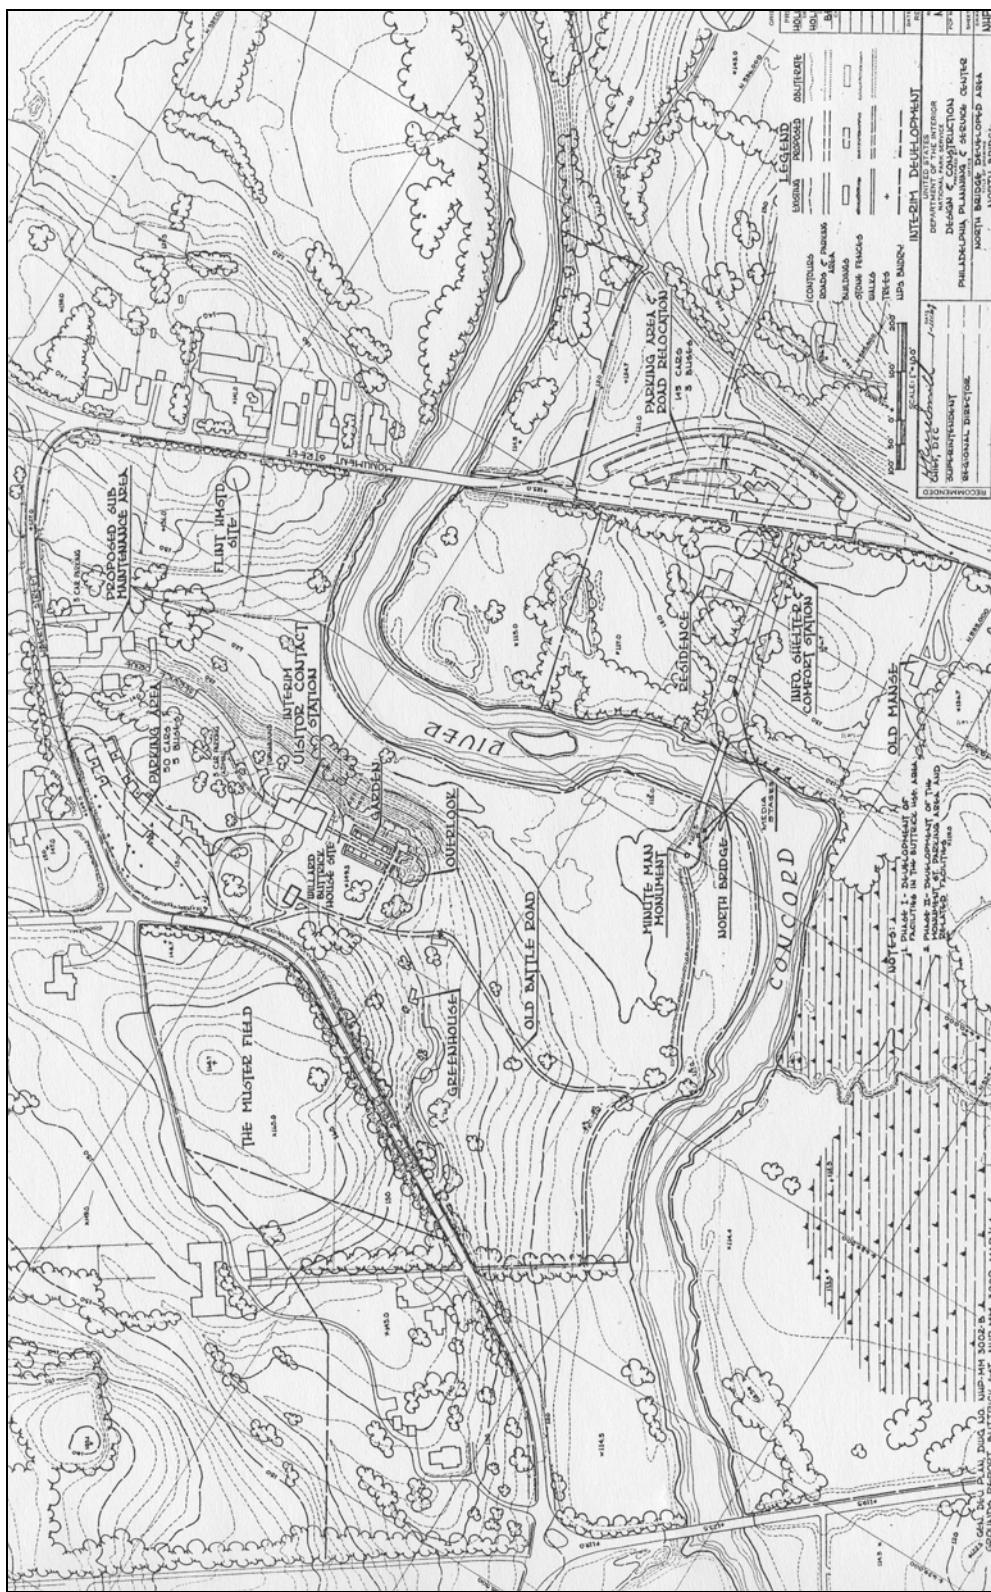
**Figure 75. NPS “Interim Development” plan – North Bridge Development Area,” 1966. (NPS, Northeast Region, Planning and Partnerships Office)**

Only general recommendations for both park units were included in the 1965 master plan. In December 1966, the NPS Philadelphia Planning and Service Center prepared an “Interim Development” plan for the North Bridge Unit, detailing recommendations included in the master plan (North Bridge Visitor Center and parking lot, trail from the North Bridge to the North Bridge Visitor Center), and several new recommendations not mentioned in the plan. In addition to noting extant features, the plan proposed a new information shelter and comfort station, and re-alignment of the Monument Street parking lot (Figure 75).

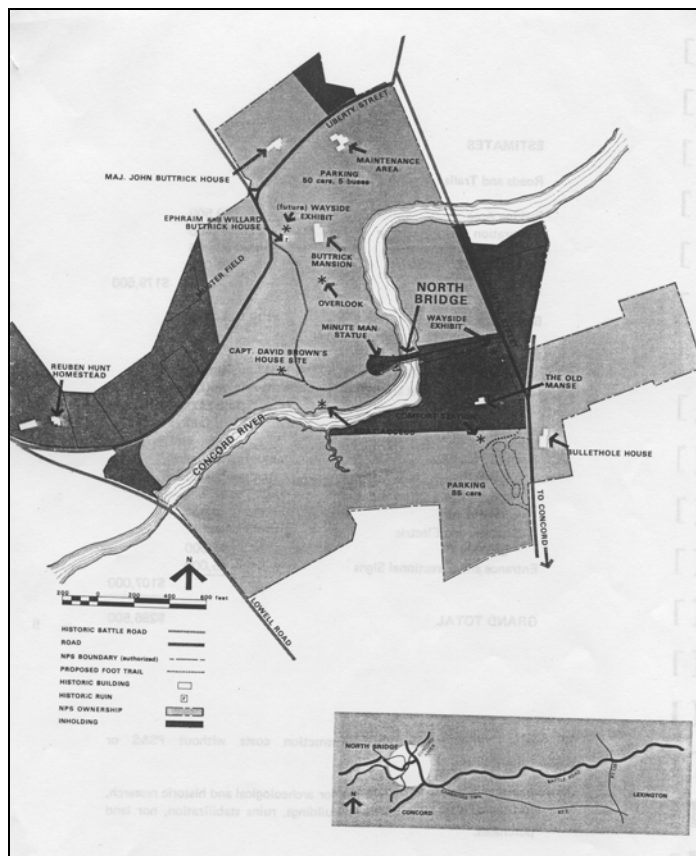
Figure 76. Plan included in the NPS report “North Bridge Development Concept Plan,” 1973 (MIMA Library).

The 1973 “North Bridge Development Concept Plan” addressed the problems outlined in the “Interpretative Prospectus.” The plan proposed solving the stated problems through a unified plan that included a well-defined pedestrian system with specific points of interest. According to the plan, direct, well-designed walks would “channel” visitors through the landscape to wayside exhibits. The plan proposed two alternatives to eliminate the barrier separating the Monument Street parking lot and the battleground. The first alternative recommended relocating Monument Street east of the Monument Street parking lot. The second alternative recommended the acquisition of two parcels south of the Old Manse (Sargent field and south field) for the construction of a new parking lot and comfort station, eliminating the need for the Monument Street parking lot (Figure 76).<sup>206</sup> The second alternative appears to have been chosen; the two parcels were purchased by the NPS in 1973.<sup>207</sup> Although the NPS never constructed the parking lot on the two parcels as planned, Sargent field serves today as an overflow parking area.

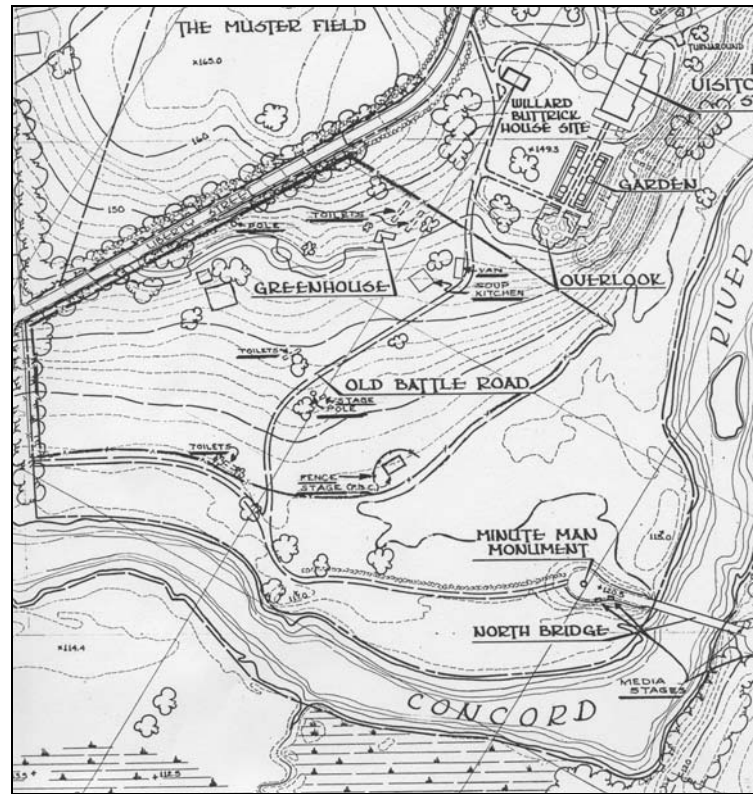
Figure 78. Section of the NPS "Interim Development" plan – North Bridge Development Area," 1966, with hand written notes from c. 1975 indicating the intended or actual locations of temporary PBC program amenities on the hillside west of the North Bridge. (NPS, Northeast Region, Planning and Partnerships Office)

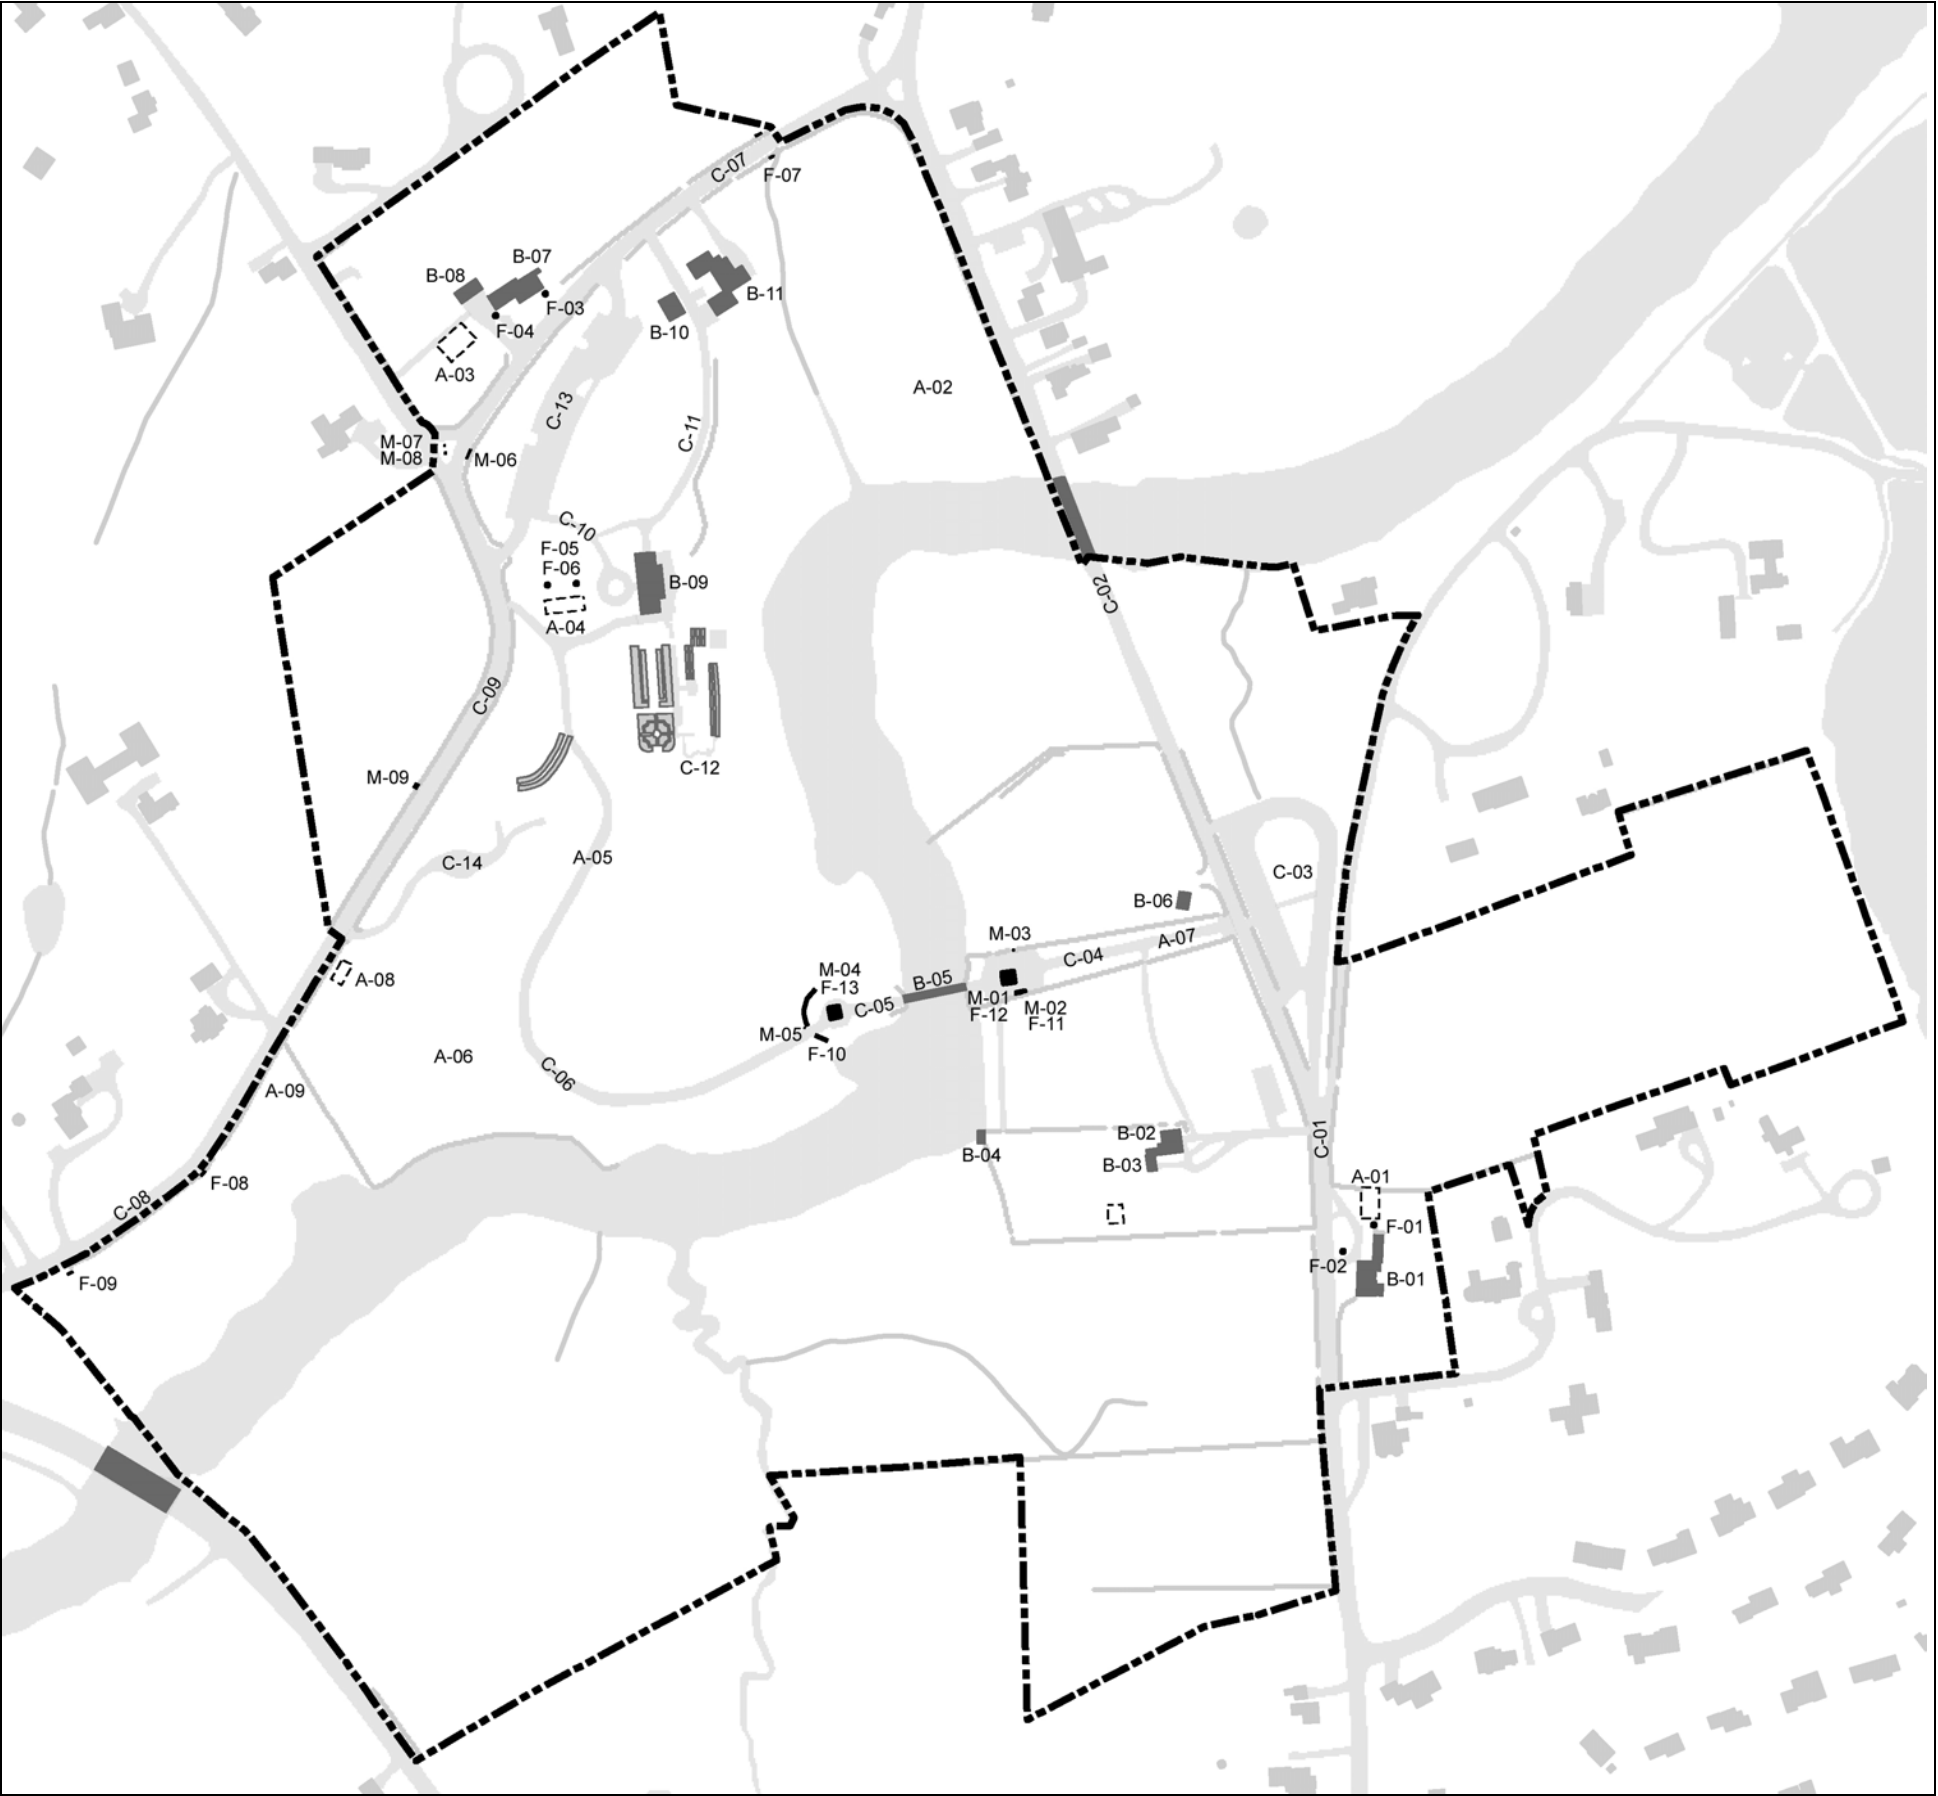
Figure 81. Location of buildings and structures, circulation, archeological sites, monuments, and miscellaneous small scale features, 2003. (OCLP)

Existing Condition: The location of the feature and a description of its physical condition. Refer to Figures 81, 82, and 83 for feature locations.

### **Spatial Organization** (see Figures 81, 82, and 83)

**Circulation** (see Figure 81)

### Buildings and Structures (see Figure 81)

**Archeological Sites** (see Figure 81)

### Small-Scale Features – Monuments and Markers (see Figure 81)

**Small Scale Features – Miscellaneous** (see Figure 81)

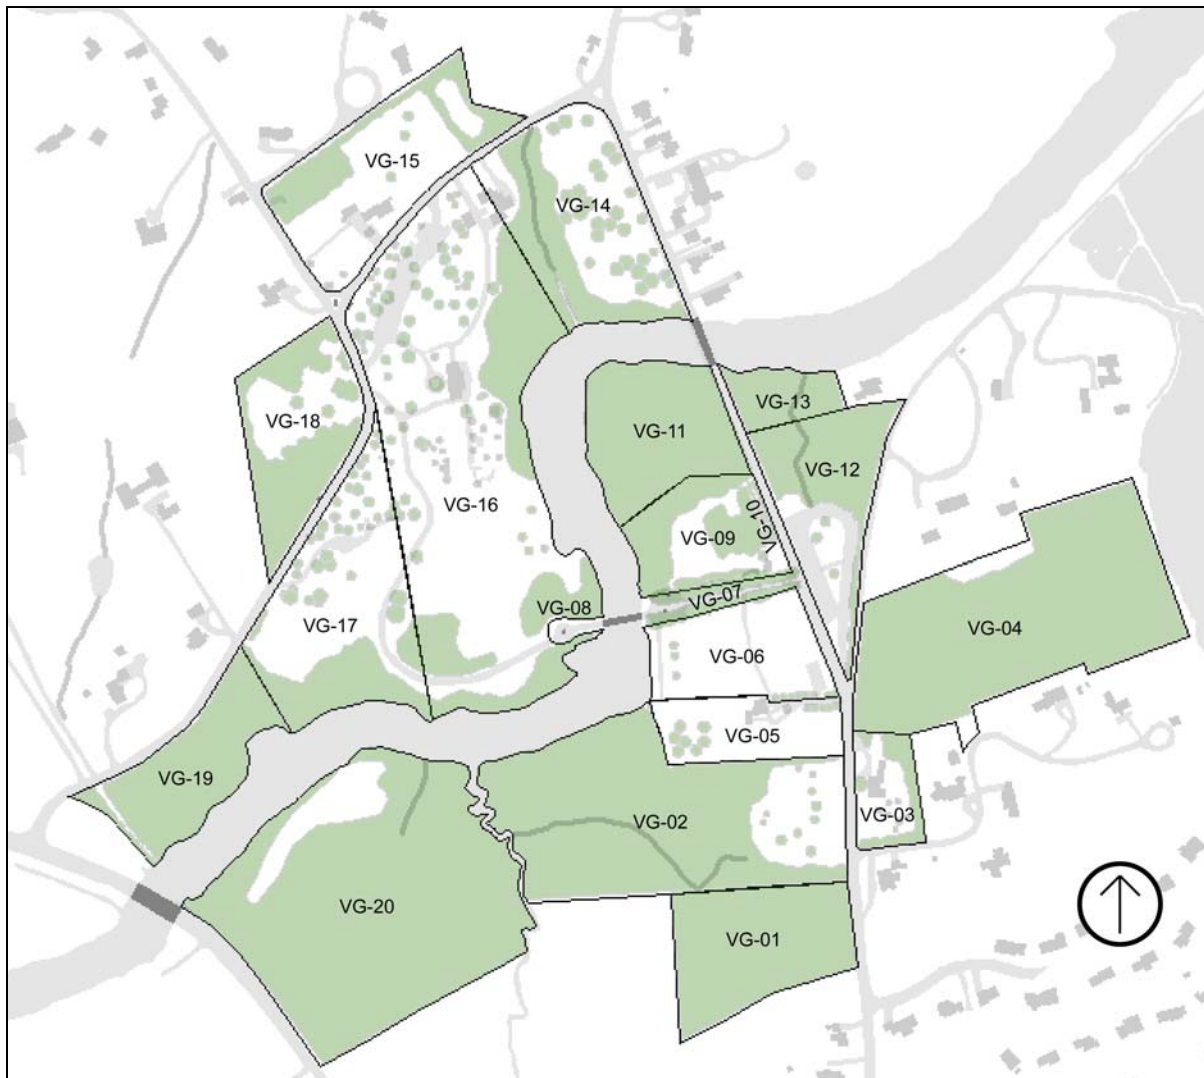
**Figure 82. Vegetation location map, 2003. (OCLP)**

### **Vegetation** (see Figure 82)

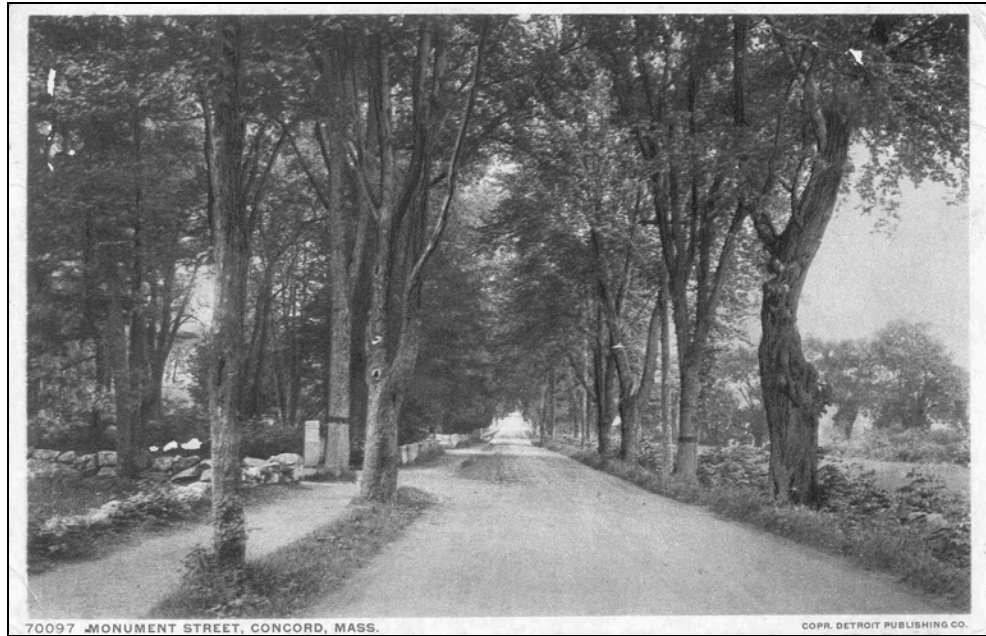
Figure 84. Postcard view north of Monument Street, postmarked 1916. Depicted on the postcard is stone wall (W-12) bordering the Old Manse field (left), and stone wall (W-18) bordering the avenue leading to the bridge. The two walls intersect at the entrance to the battleground. (MIMA Postcard Collection, Box 1, #13637, MIMA Archives)

Historic Condition: Present-day Monument Street is believed to include a portion of the historic Groton Road, which lead north from the center of the town, then turned west and crossed the North Bridge. British soldiers marched along the road to and from the battle at the North Bridge. When the North Bridge was removed in the early 1790s and Flint's Bridge was constructed further down stream, the road was extended north to cross the new bridge. Property deeds from the 1830s indicate the road was known as the "road leading from Concord to Carlisle and Lowell" and simply the "road leading to Carlisle."<sup>217</sup> By 1875 the road was known as "Monument Street." Middlesex County Commissioners ordered road improvements in 1875, 1901 and 1924.<sup>218</sup> The 1901-1902 Concord Town Report states the road was "worn out and not fit condition for the amount of travel compelled to use it. There is probably more traffic over this street in the summer than on any other in Town (Figure 84)."

Historic Condition: Stone wall (W-20) did not exist in 1775. A stone wall appears in the same location as stone wall (W-20) on the 1875 layout plan for Monument Street, within the bounds of proposed road alterations. A wall in the same location as stone wall (W-20) does not appear on the 1916 “Plan of the Old Manse Property,” indicating it was removed during road alterations. The wall re-appears on a postcard of Monument Street postmarked 1916 (published c. 1910-1920) which may indicate the wall was replaced in 1916 (see Figure 84). It also appears on the 1924 layout plan for Monument Street.

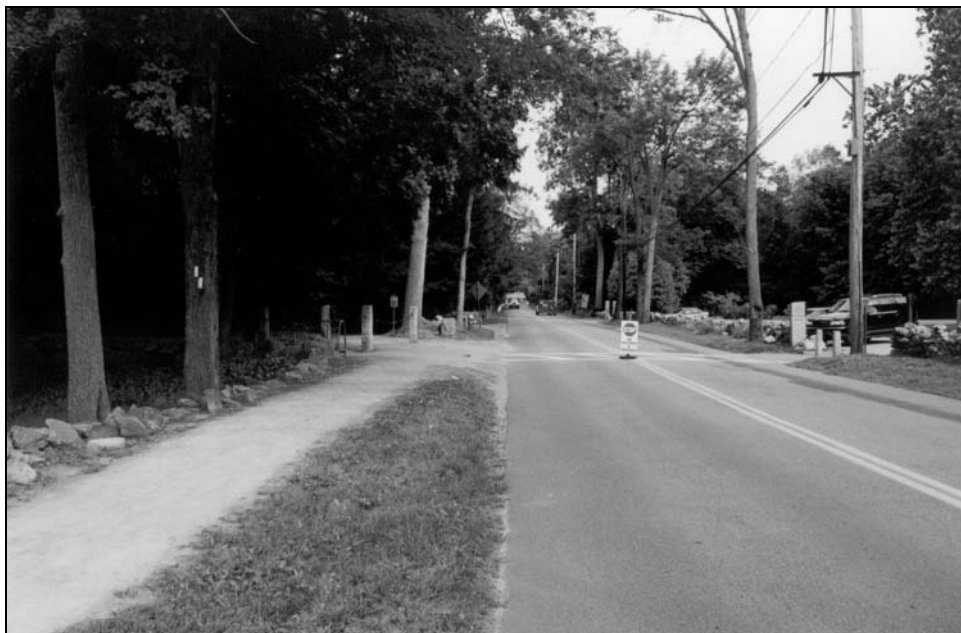
Figure 85. View north of Monument Street, 2002. Note stone wall (W-16) bordering the Monument Street parking (right), Stone wall (W-12) bordering the Old Manse field (left), and the pedestrian crosswalk. (OCLP)

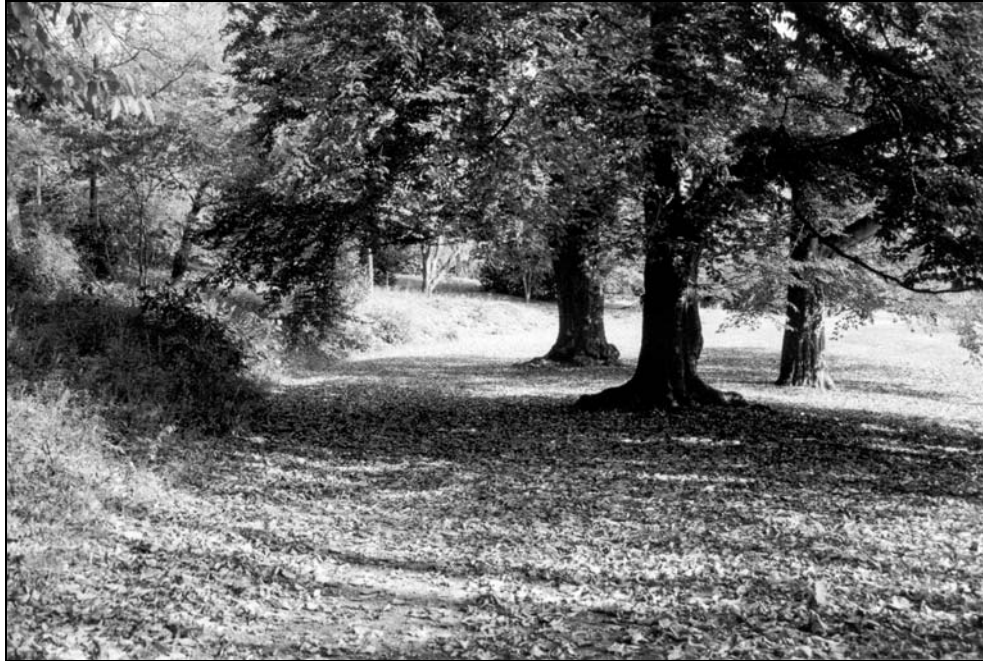
Figure 86. View northeast of Battle Lawn entrance drive, 2002. (OCLP)

Existing Condition: Topography and surface conditions indicate the location of the nineteenth-century drive. Its present configuration appears to the same as the route depicted on the 1889 atlas (Figure 86).

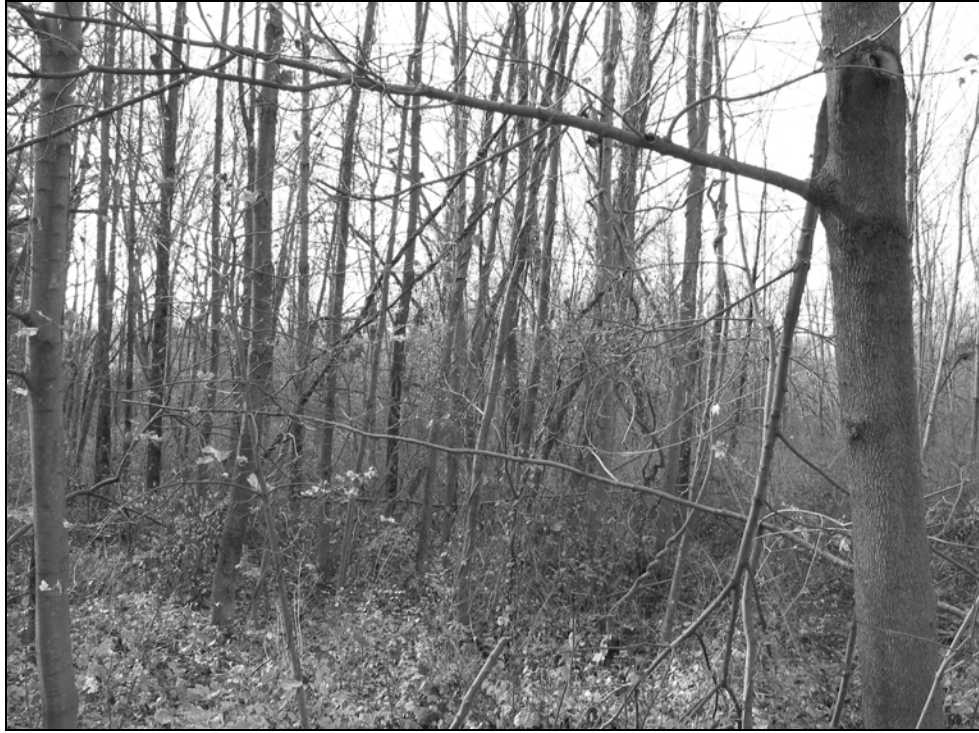
**Figure 87. View west of south field from Monument Street sidewalk, 2002. (OCLP)**

Existing Condition: The field is located on the west side of Monument Street, south of Sargent field. A forest with dense underbrush covers the site, limiting access. Oaks (*Quercus sp.*) appear to dominate the site, some with trunk diameters measuring 36 inches. Elm (*Ulmus sp.*) and Norway maples (*Acer platanoides*) are also present. Underbrush includes bush honeysuckle (*Lonicera sp.*), oriental bittersweet (*Celastrus orbiculatus*), and multiflora rose (*Rosa multiflora*) (Figure 87).

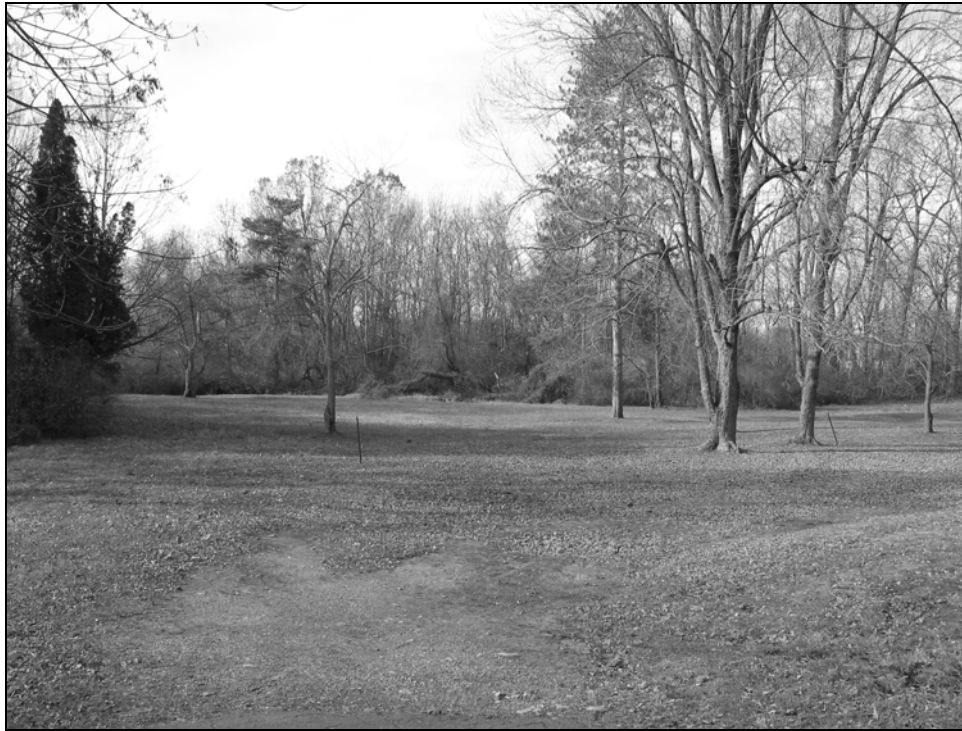
**Figure 89. View west of Sargent field (eastern section) toward the Sargent house site, 2002. The field is currently used as an NPS overflow parking lot. (OCLP)**

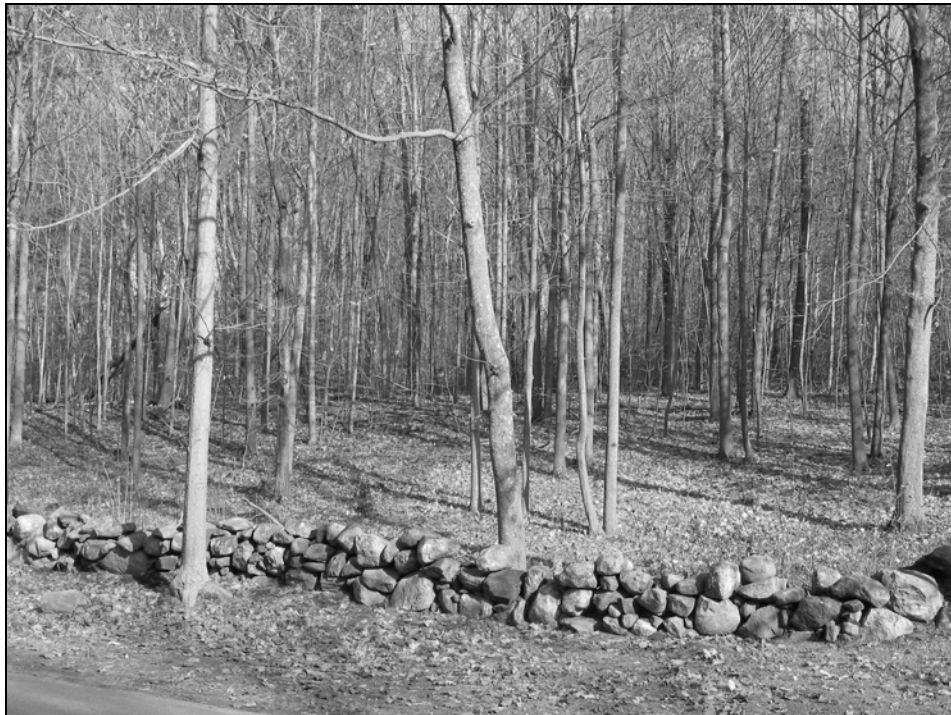
Figure 92. View northeast of Poplar Hill and stone wall (W-13), 2002. (OCLP)

Existing Condition: Poplar Hill is located west of Monument Street, just north of the Elisha Jones houseplot. The site rises to 205 feet above sea level, and is covered with a mature forest dominated by species of oak (*Quercus sp.*), hickory (*Carya sp.*), and maple (*Acer sp.*). Other species include white pine (*Pinus strobus*), red pine (*Pinus resinosa*), linden (*Tilia sp.*), black walnut (*Juglans nigra*), spruce (*Picea sp.*), American beech (*Fagus grandifolia*), and dogwood (*Cornus sp.*). The forest is composed of multi-aged trees, from young saplings to mature trees with trunk diameters averaging 24 to 30 inches. One red oak observed had a trunk diameter of 36 inches. In addition to native species, the forest supports a number of invasive exotic plants including Norway maple (*Acer plantanoides*), common buckthorn, (*Rhamnus cathartica*) oriental bittersweet (*Celastrus orbiculatus*), multiflora rose (*Rosa multiflora*), barberry (*Berberis sp.*), and winged euonymus (*Euonymus sp.*). A neighboring landowner has cleared a rectangular section of forest adjacent to the southern boundary of his property, and in a portion of the cleared section he has planted lawn and ornamental trees (Figures 92-93).

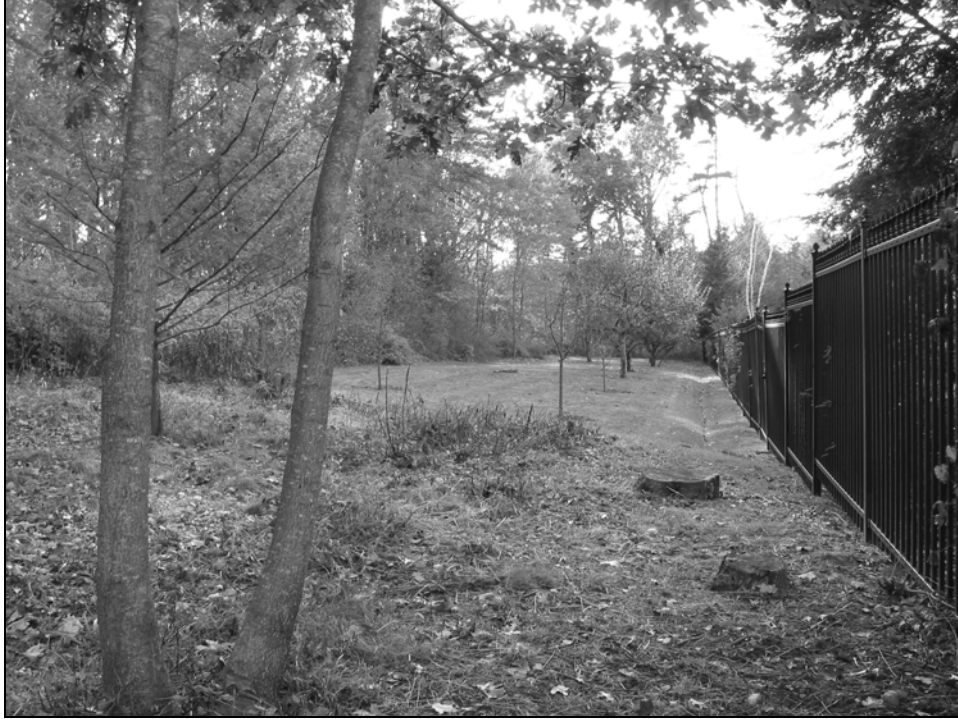
**Figure 93.** View southwest of Poplar Hill, along northern border (iron fence), 2002. Note tree stumps, lawn, and ornamental trees planted by neighboring landowner within park boundary. (OCLP)

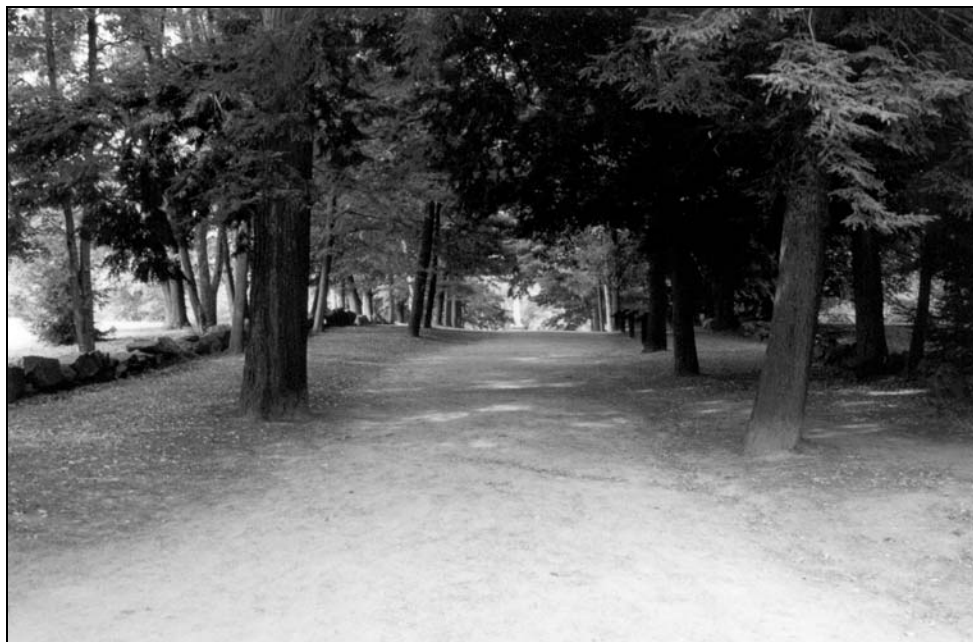
Figure 96. View west of the allée from the entrance to the battleground, 2002. (OCLP)

The age and species of the trees indicate several eras of tree planting are represented within the extant allée. The oldest documented tree is the sugar maple flanking the Grave of the British Soldiers. The maple is one of two deciduous trees that appear in historic photographs flanking the grave, the earliest photograph dating to c. 1875 (see Figure 24). The extant tree appears to have an approximate 12-inch trunk diameter in the historic photograph. Today the maple has a trunk diameter of 30 inches. This tree, as well as possibly several other sugar maples, an ash, and a hemlock (trunk diameters 28 to 30 inches) predate the centennial anniversary and may have been apart of the original planting in 1838 or the replanting in the mid-1840s. Several hemlocks and sugar maples (trunk diameters 15 to 30" inches) may date to the 1930s planting, and several white pine, red pine, larch, and red oak (trunk diameters 8 to 12") probably date to the early 1950s planting.
